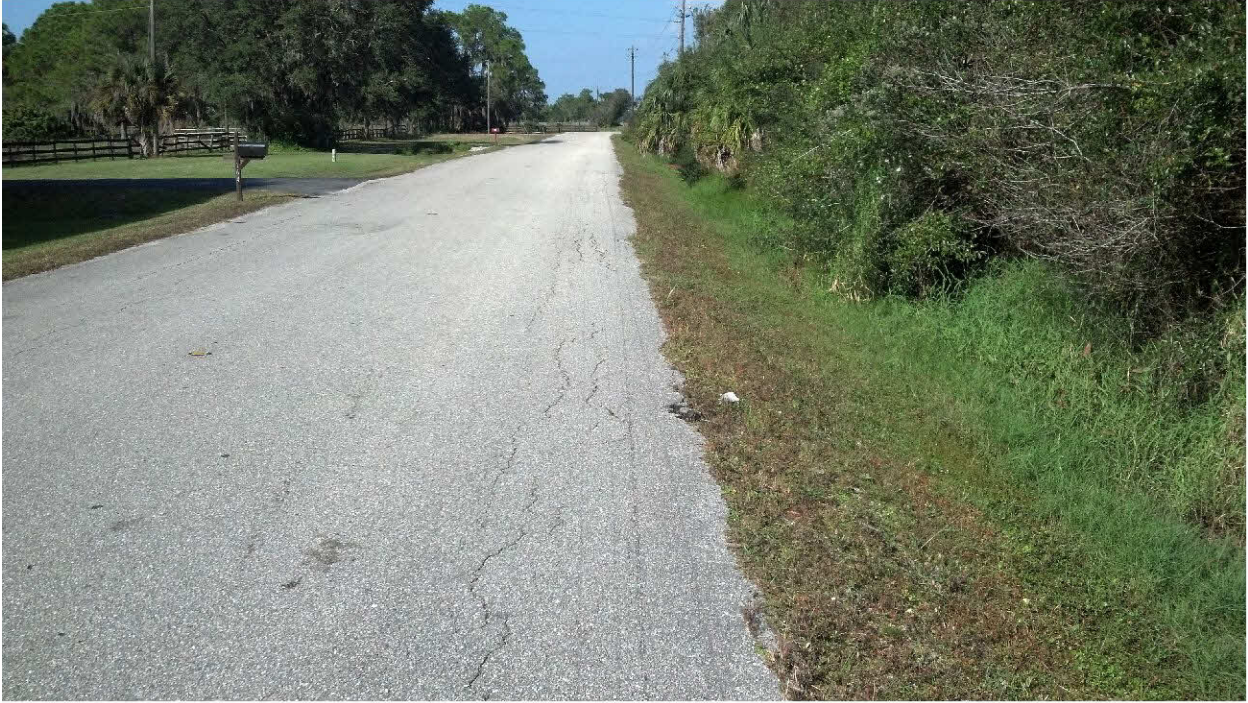
Cowpen Lane cross view showing no or minimal shoulder on east side of road.

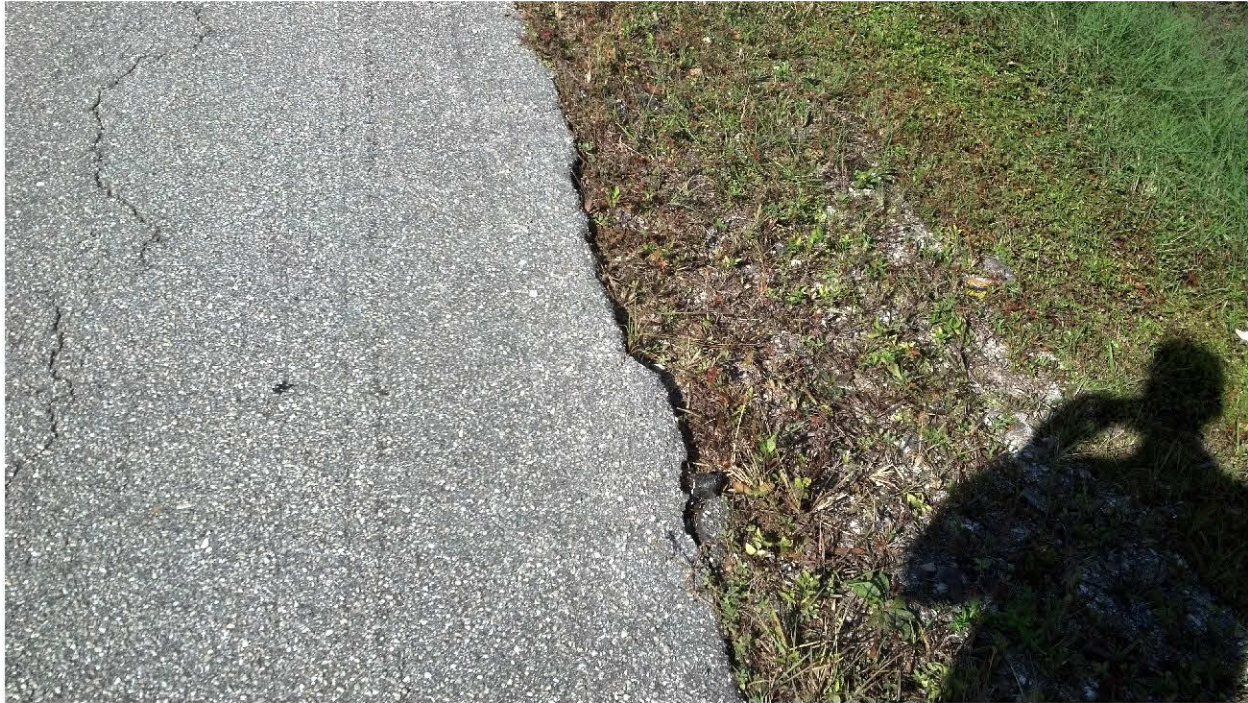
Roadway edge damage and subsidence due to lack of should to hold roadway base.

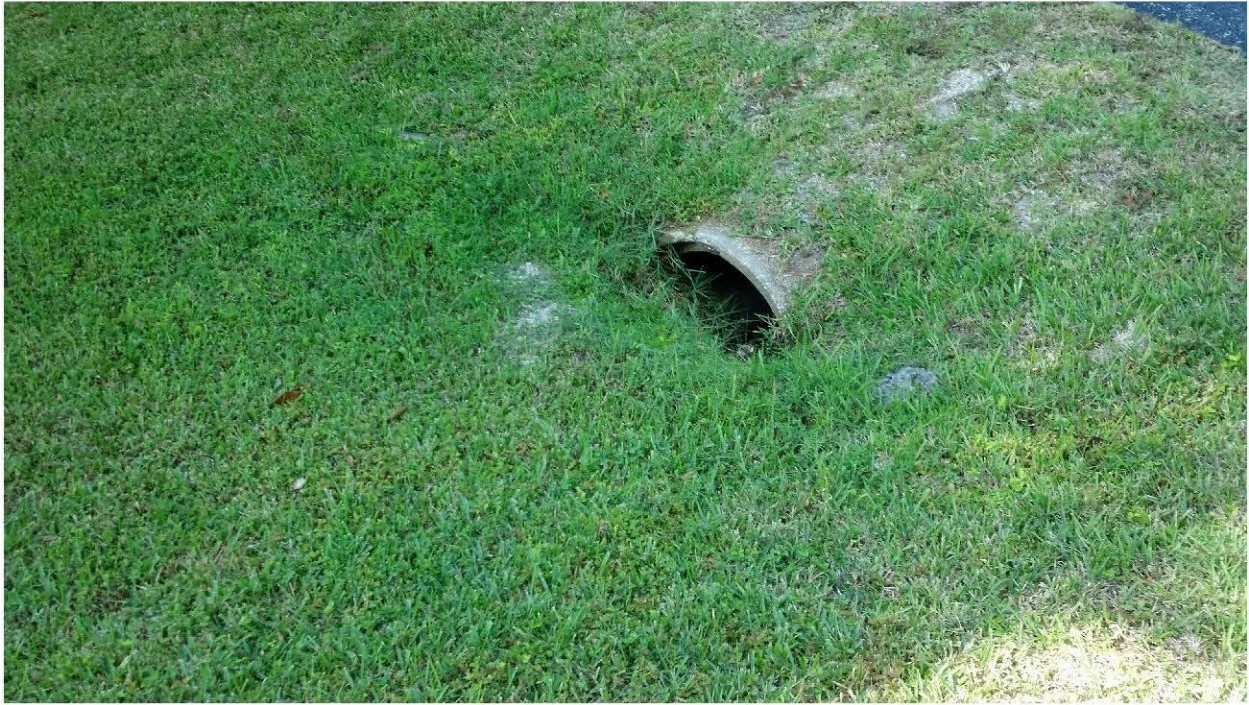
Partially clogged culvert under driveway on west side of Cowpen Lane.

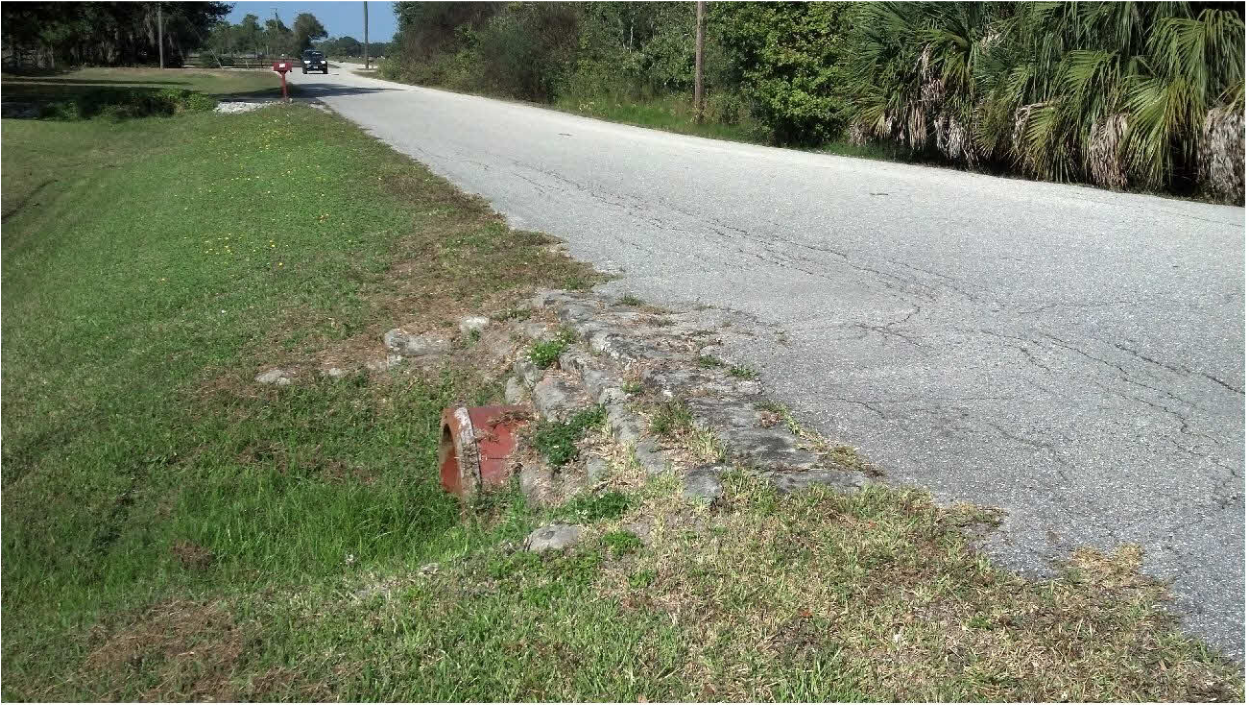
Culvert end without mitered end section extending out past the clear zone for traffic. This condition creates a hazard to vehicles that may drift off of the road wan into the ditch.

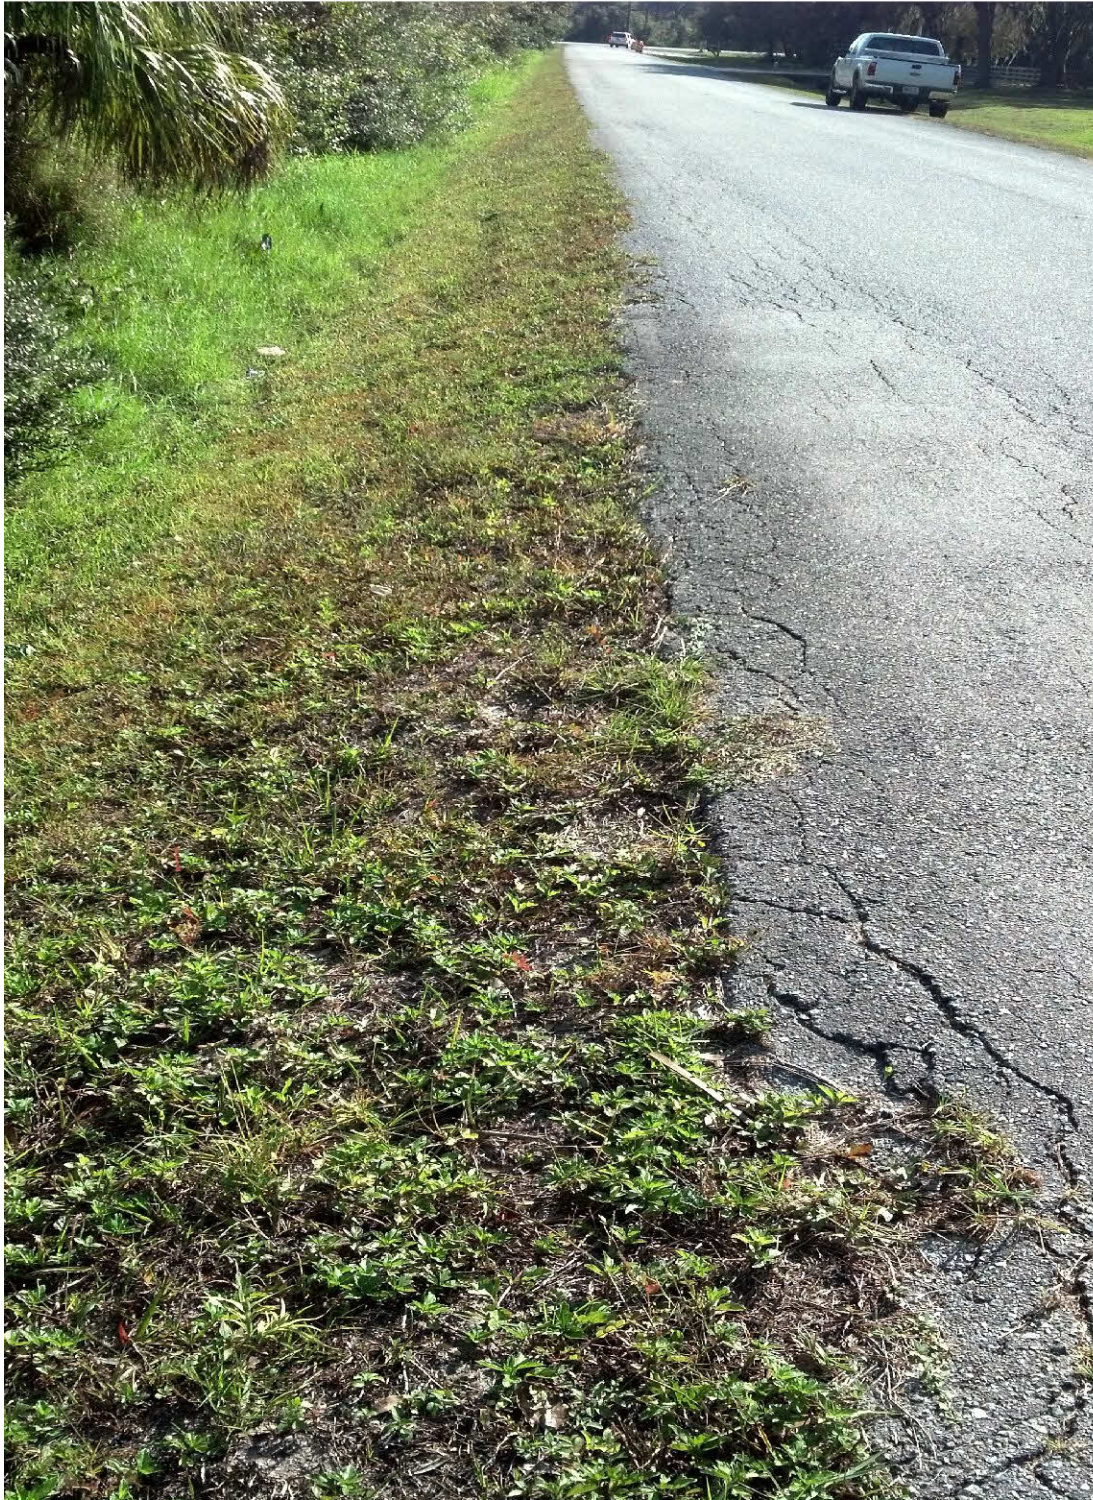
Damage to pavement on the roadway edge due in part to a lack of roadway shoulder to hold the base and pavement in place.

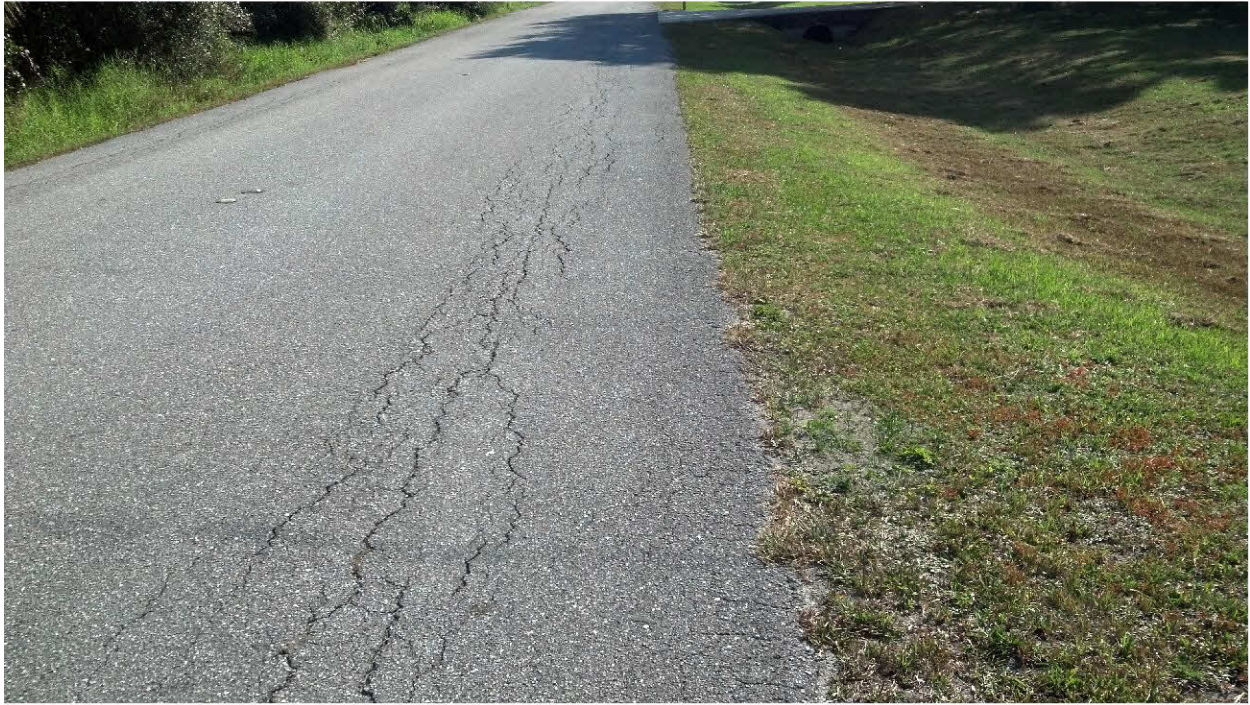
Rutting visible on outside wheel lane of roadway.

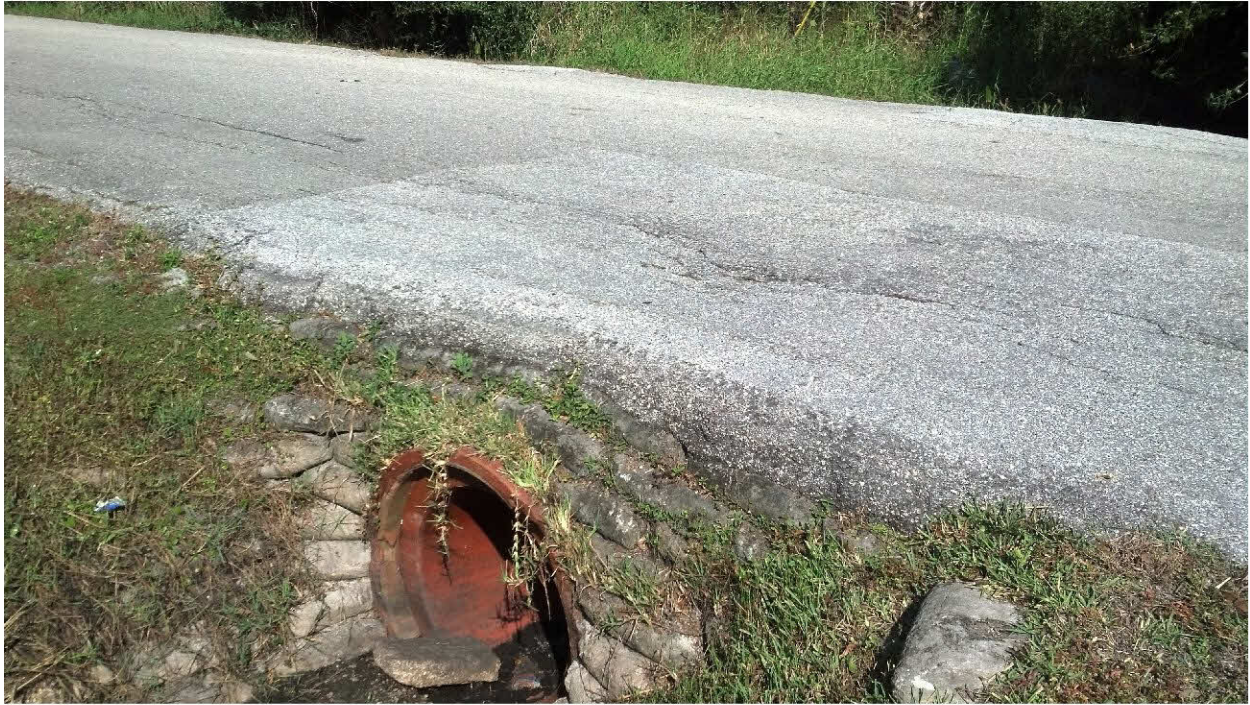
Culvert end without mitered end section extending out past the clear zone for traffic. This condition creates a hazard to vehicles that may drift off of the road wan into the ditch.

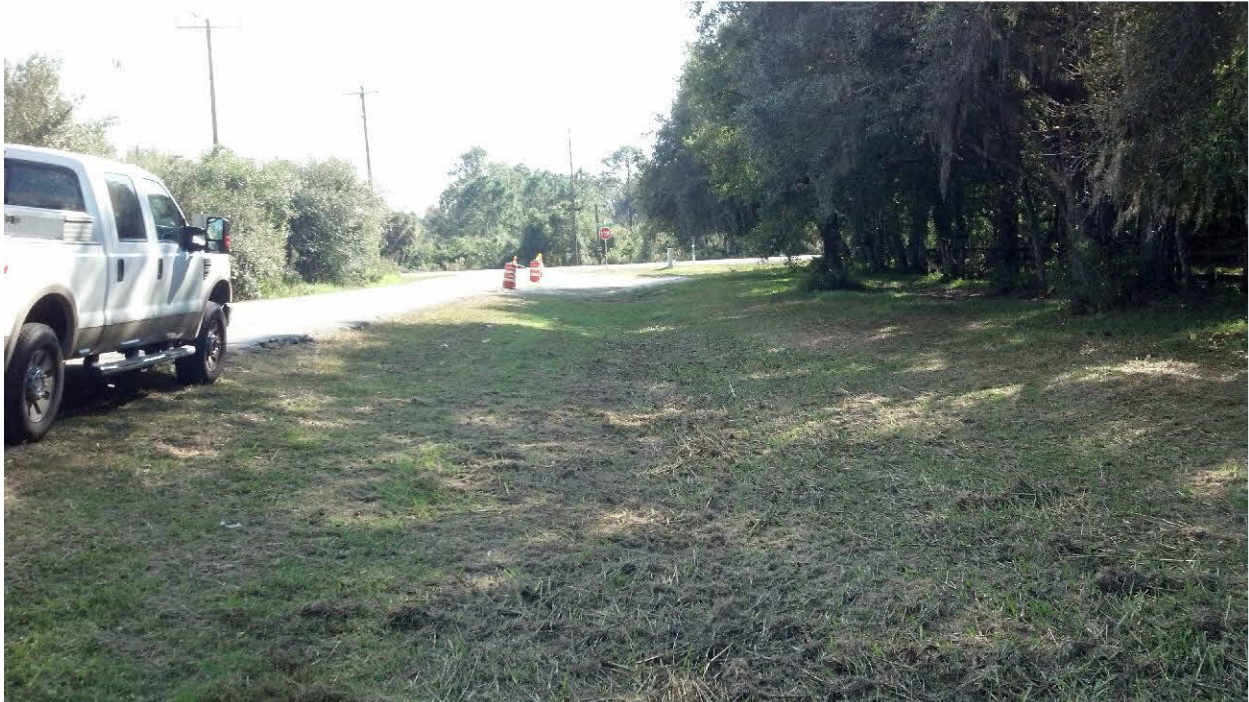
Shell area in northwest corner of intersection. This filling of the ditch eliminates or hinders drainage flows along the west side ditches of Cowpen Lane just before they enter the drainage system of Fruitville road. Though unsubstantiated, this condition would likely cause drainage flows on the west side of the roadway to back up and hinder drainage flows from the east side of Cowpen Lane to the west side of the road. This condition would be a contributing factor to the flooding and overtopping of the roadway.

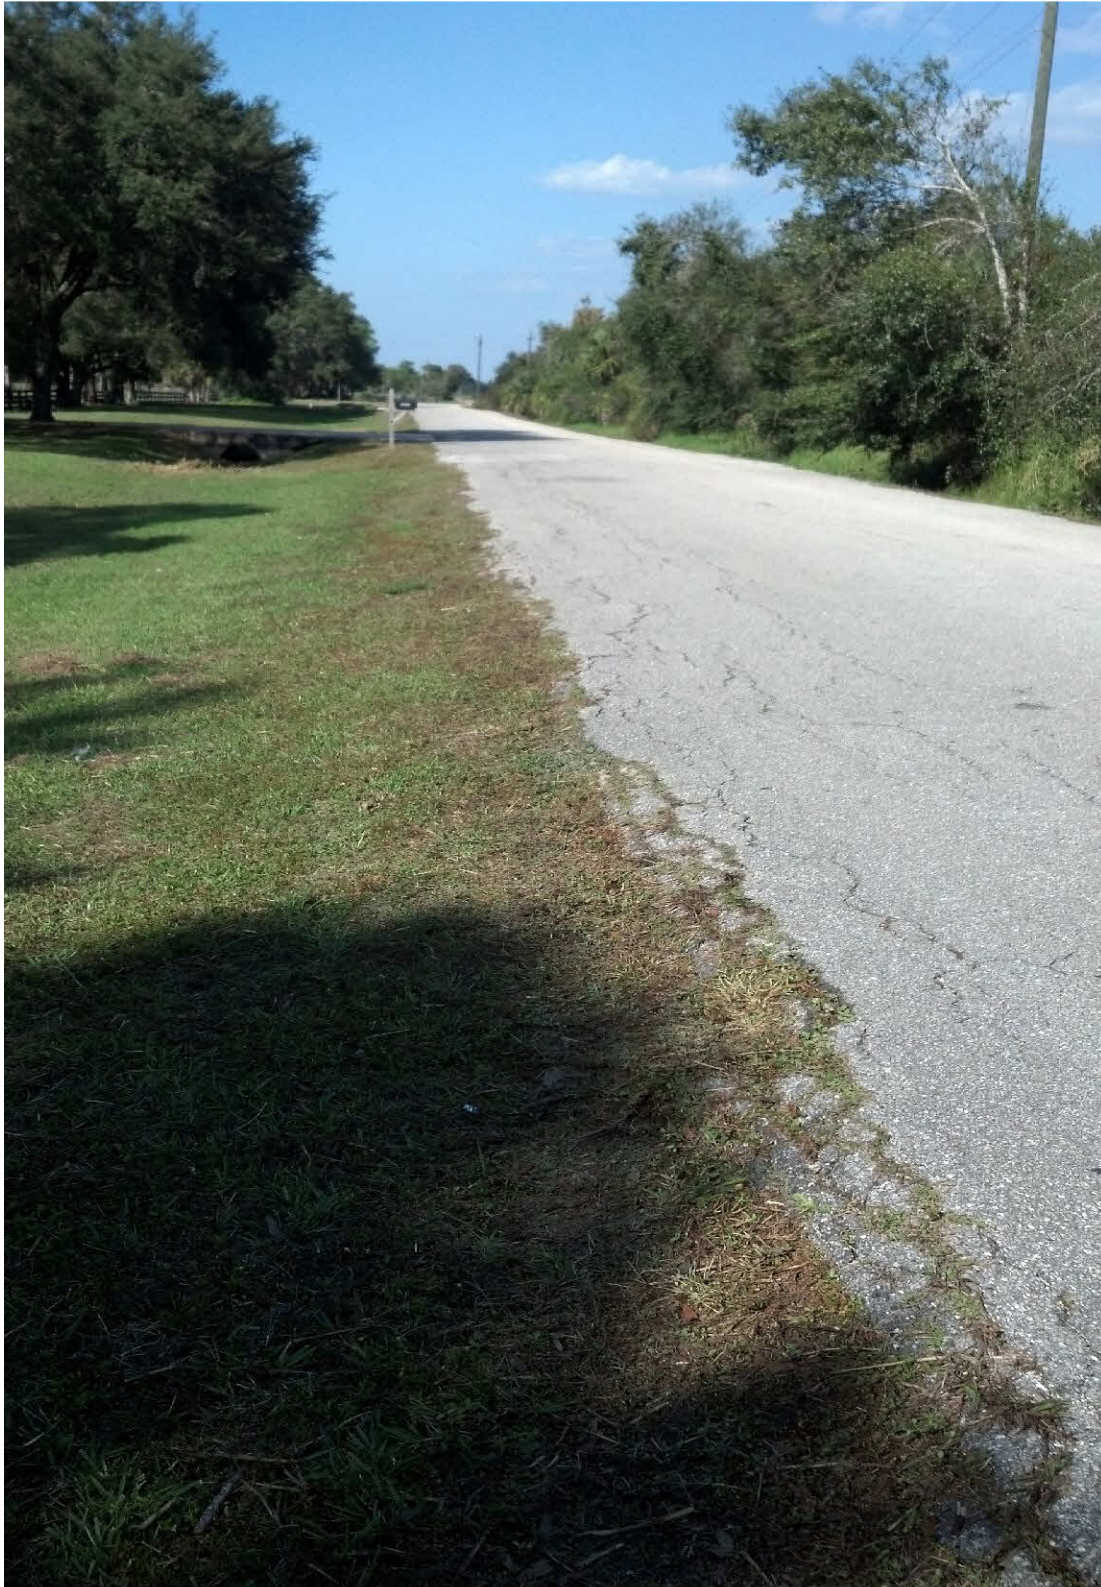
Damage to pavement on the roadway edge due in part to a lack of roadway shoulder to hold the base and pavement in place.

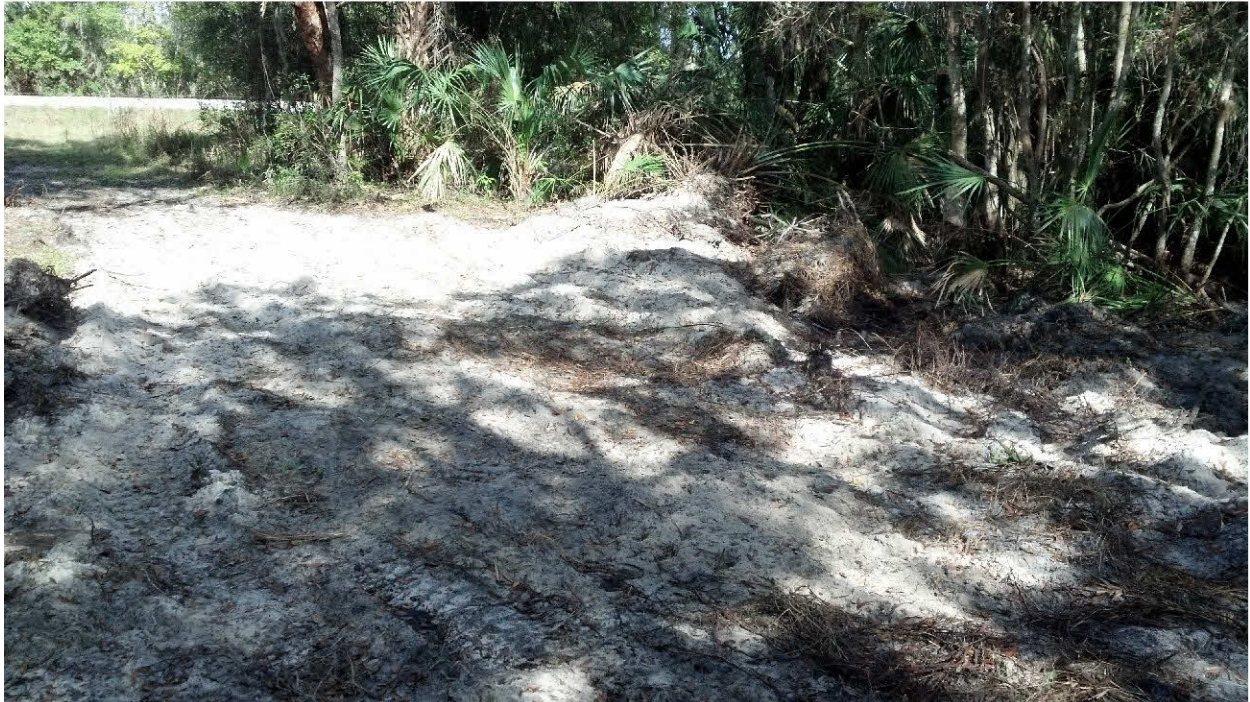
The channel of Cowpen Slough filled on the south side of Fruitville road. Fruitville Road is in the background. It appears as this may be an attempt to construct a crossing form livestock and agricultural vehicles.

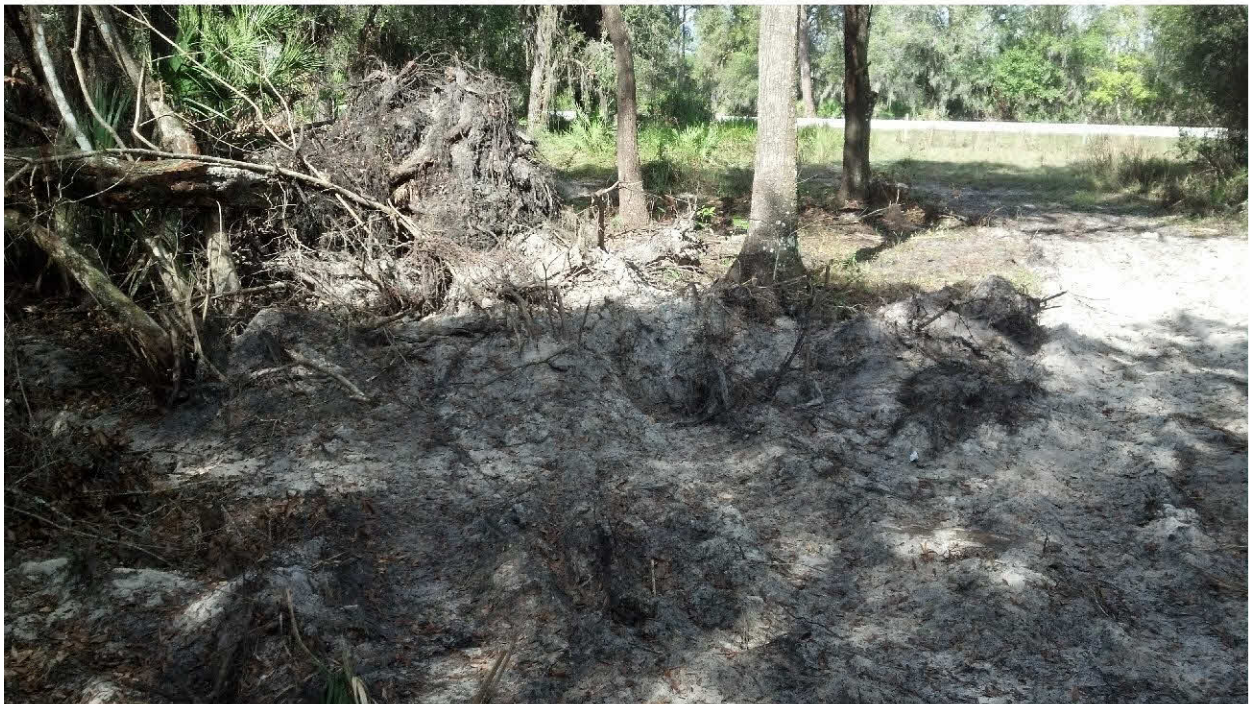
Additional views of the clearing and filling of the channel of Cowpen Slough south of Fruitville road. Note the existing ditch of the channel in the left hand side of the photo.

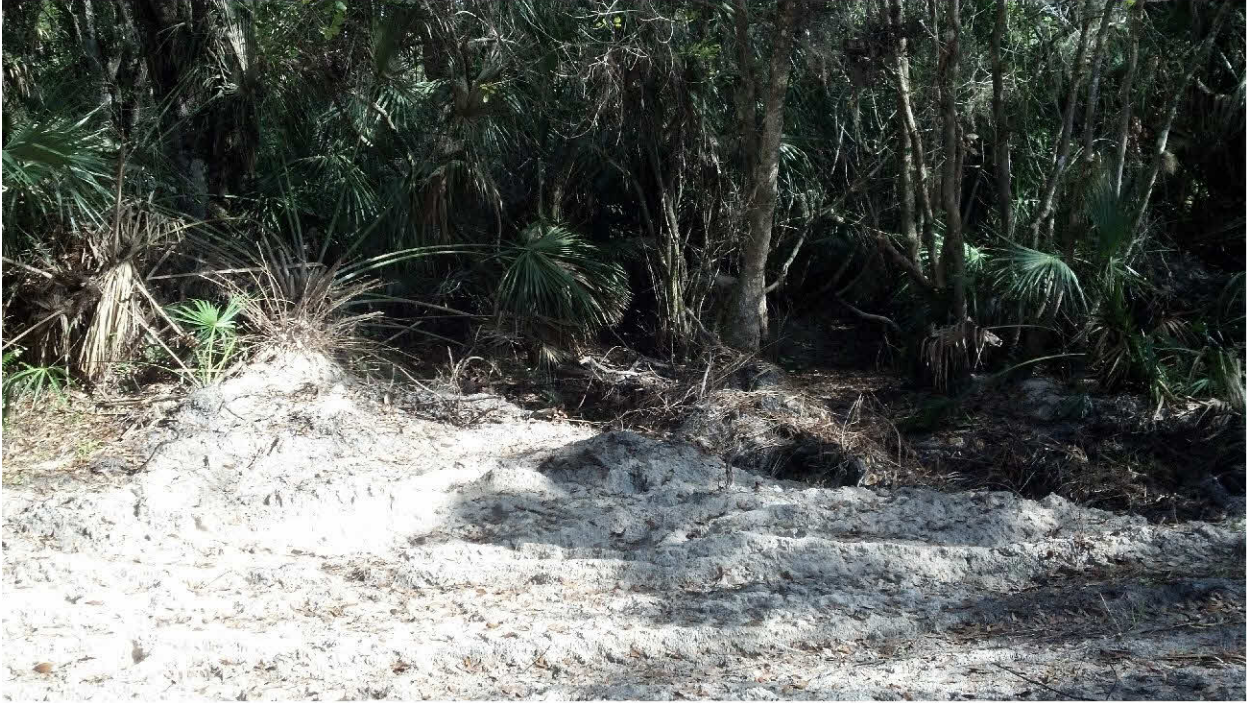
Clearing and filling of the Cowpen Slough Channel.

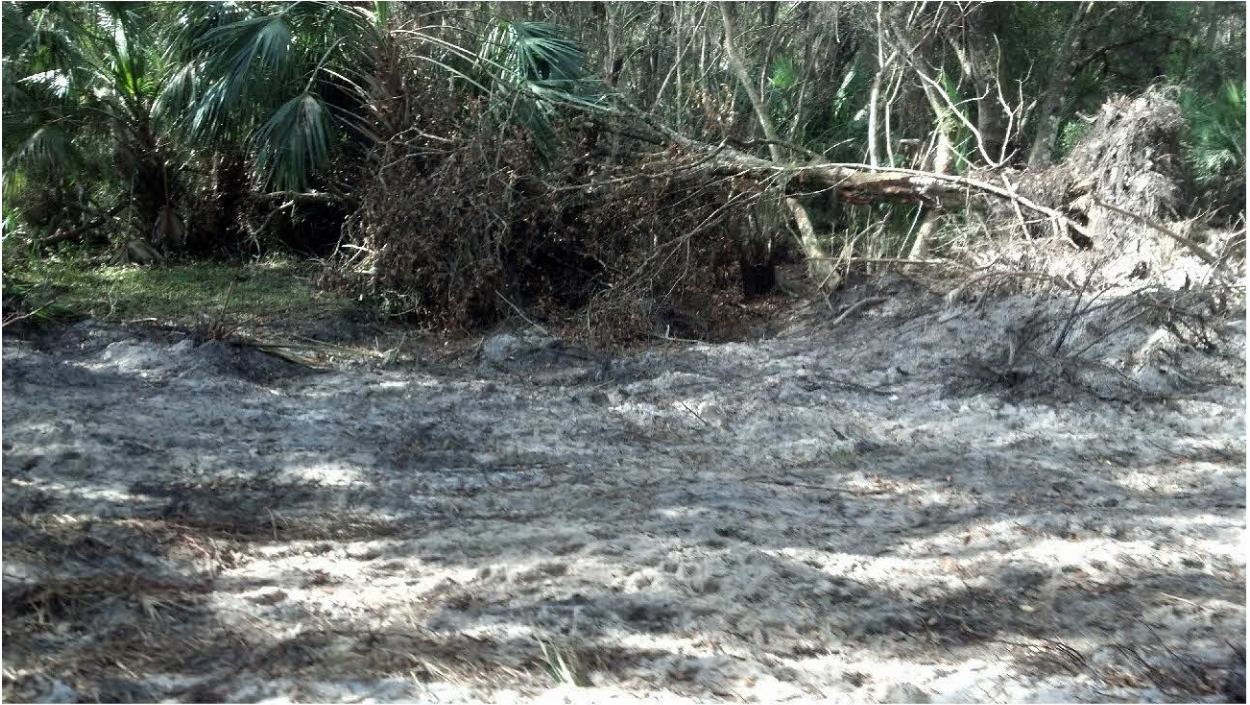
Clearing and filling of the Cowpen Slough Channel.
